A STUDY OF STIFFNESS, RESIDUAL STRENGTH AND FATIGUE  
LIFE RELATIONSHIPS FOR COMPOSITE LAMINATES

# **A Study of Stiffness, Residual Strength and Fatigue Life Relationships for Composite Laminates**

**J.T. Ryder  
F.W. Crossman**

LOCKHEED-CALIFORNIA COMPANY  
A Division of Lockheed Corporation  
Burbank, California 91520

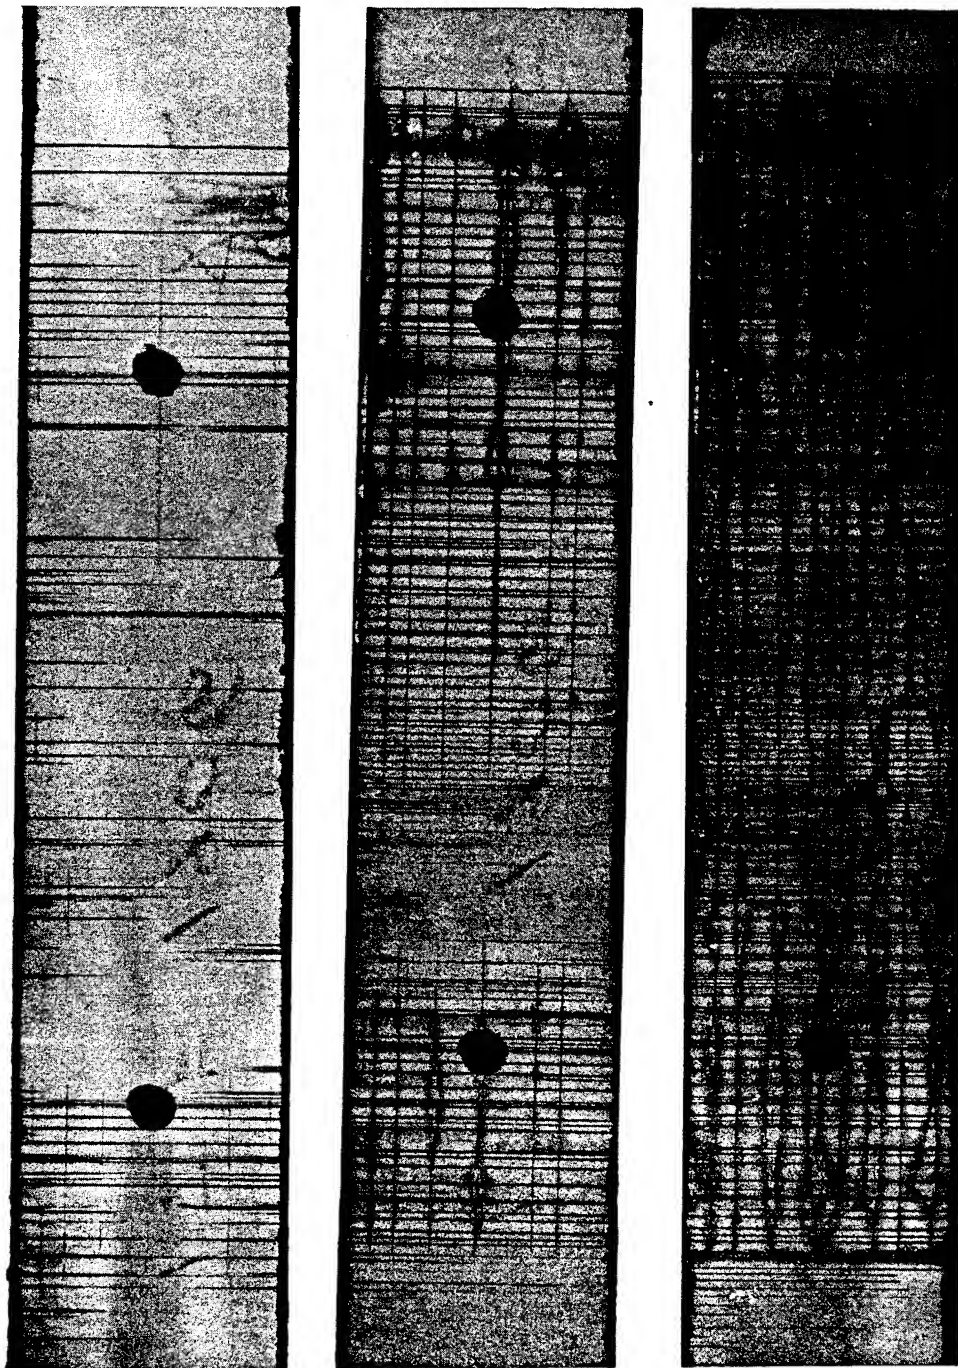
Figure 39: Enhanced x-ray photographs of coupon A6 showing  $90^\circ$  matrix cracking,  $0^\circ$  splits, and delamination; Initial  $\epsilon = 0.006$ .
